# Corrosion Testing Apparatus

Department of Mechanical and Mechatronic Engineering, Eastern Mediterranean University

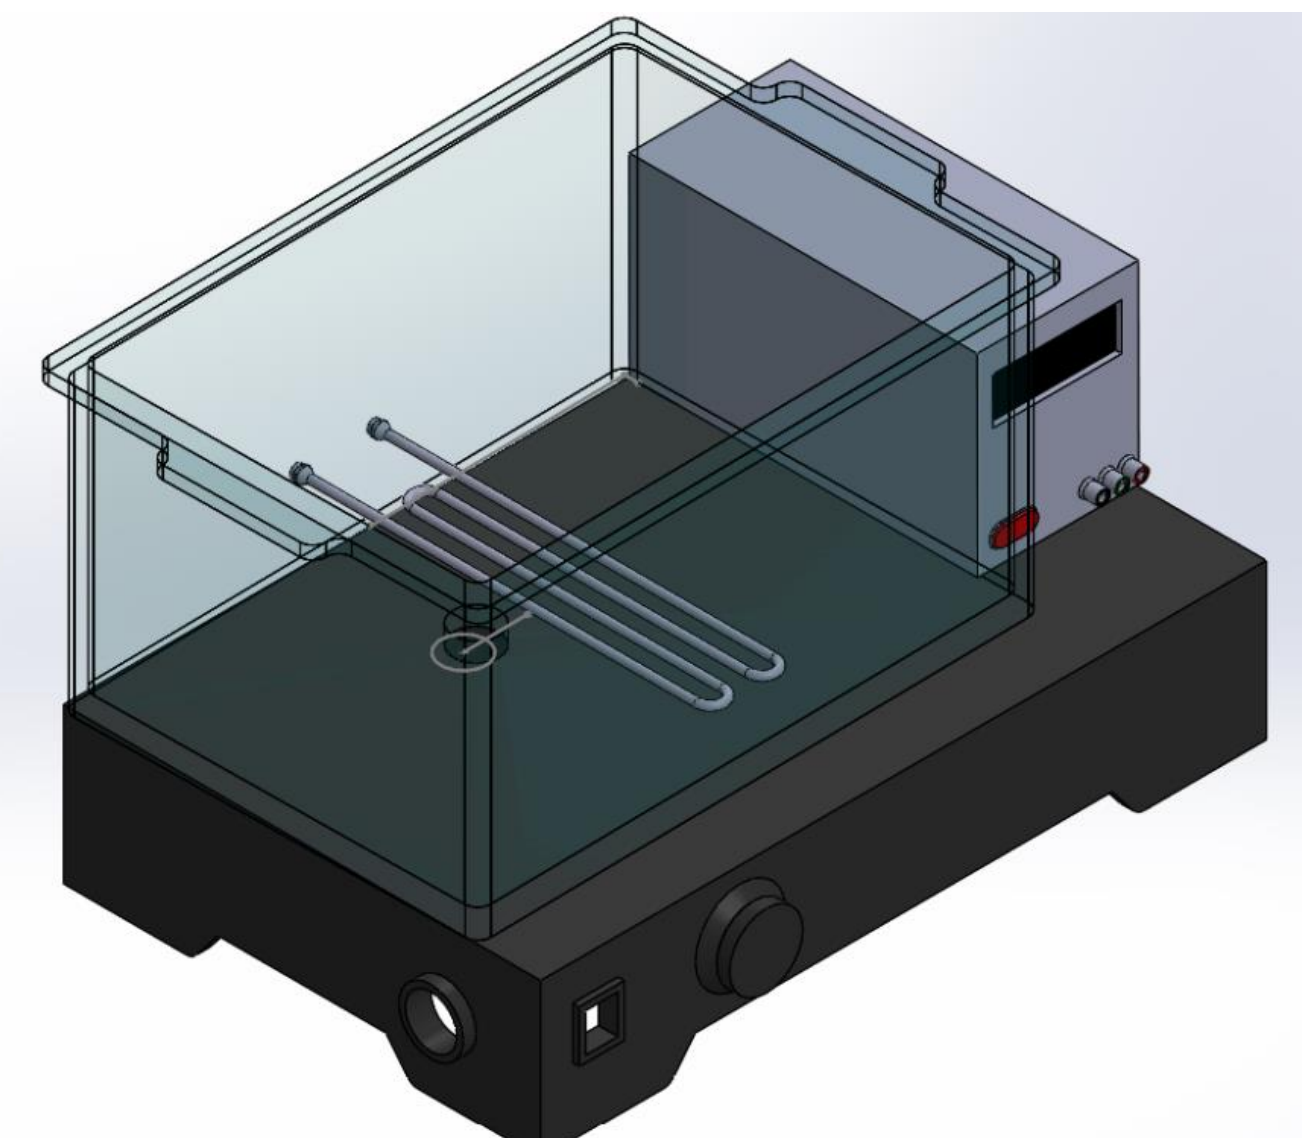
## Design components:

- Base
- Container
- Titanium Heater
- DC Power Supply
- Water Pump

The Machine was designed to allow for a uniform solution temperature in the testing chamber by using the water flow circulation system and a water heater which are both controlled manually.
